## Structural and Non-Structural Measures for Flood Risk Mitigation in the Bâsca River Catchment (Romania)

The most common natural hazards affecting the Bâsca River Catchment (extended over a surface of 785.1 sq. km in the Curvature Carpathians) are floods and flooding. The purpose of this paper is to investigate and analyze structural and non-structural measures for flood risk mitigating in this catchment.

Considerations on structural and non-structural measures for protection against floods are presented in the last part of the paper. An inventory of structural works in the middle and lower part of the catchment (hydraulic and erosion control works) and their condition was made.

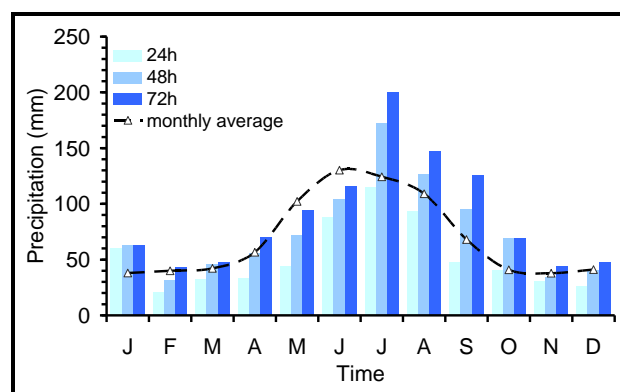
**Fig. 2 Maximum precipitations (rain and snow) in short periods reached at Lăcăuți w.s. (1961-2000)**

At annual time scale, the highest average amount of annual precipitation was recorded in June at Lăcăuți w.s. (130.2 mm in the period 1961-2000) (Fig. 2) and in July at the Penteleu w.s. (117.4 mm, in the period 1988-2007).

The maximum amounts of precipitation fallen in 24, 48 and 72 hours, at Lăcăuți were recorded in July (Fig. 2). On July 12<sup>th</sup> 1969, at Lăcăuți w.s. it was recorded: 115.4 mm in 24h (88.6% of monthly multiannual average), 172.8 mm in 48h (132.7% of the monthly multiannual average) and 200.7 mm in 72h (154.1% of monthly multiannual average) (Fig. 2).

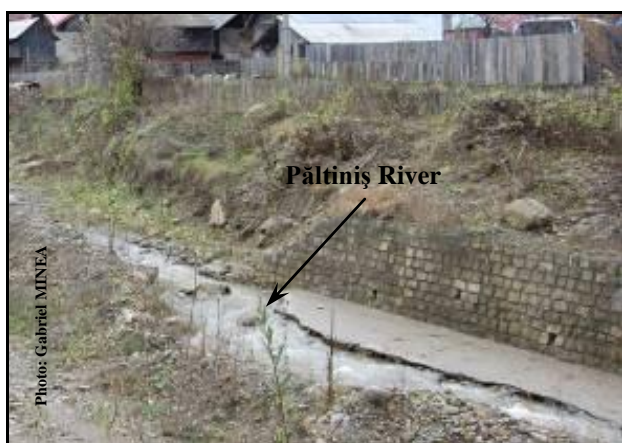
**Photo 1** Hydrotechnical work destroyed by the flood from July 20<sup>th</sup> 2002 (near the confluence of the Păltiniș with the Bâsca River)

- landslide reactivation and destabilization of slopes;
- destruction of some hydrotechnical works (Photo 1);
- affecting sections of the local road DC75;
- homes flooded in the area of the confluence with the Bâsca River and
- one human death.

These consequences are probably due also to the fact that the works were in most cases hydrologically (exceeded by flood values and channel shifting) and lithologically (alternating layers with hard resistance with friable rocks), limited.

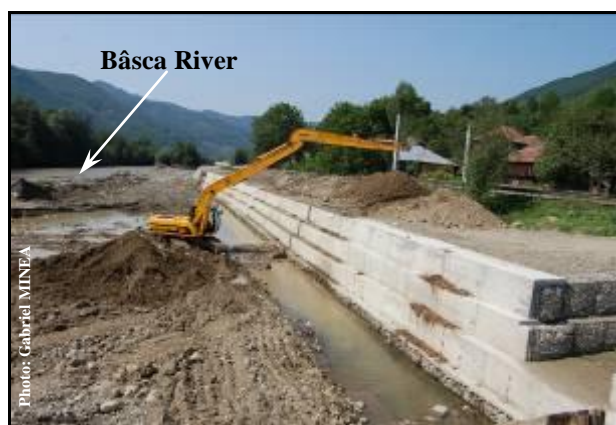
**Photo 2** New hydrotechnical arrangements (gabion baskets) on the Bâsca River (august 10<sup>th</sup> 2010)

After 2007, in the lower sector of the Bâsca River, new longitudinal hydrotechnical works (dykes from gabion mattress) are started (Photo 2). On the Bâsca River the project "Hydropower Siriu – Surduc Development", has been developed (being now in construction stage). This project includes a permanent water reservoir "Cireșu" on the upper part of the Bâsca River and an underground derivation "Surduc - Nehoiașu", from Cireșu Accumulation, The Bâsca River towards the „CHE Nehoiașu II" hydroelectric power station. This reservoir will mitigate the water volumes contributing to flood effects diminution.

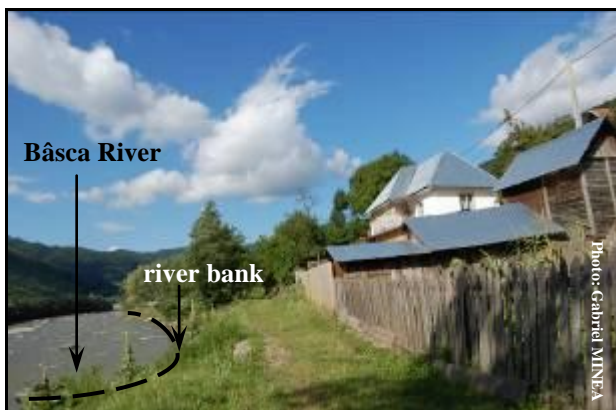
**Photo 3. Houses located in the floodplain on the right river bank of Bâsca, downstream Păltiniș Village (August 10<sup>th</sup> 2010)**

One of the reasons amplifying the negative effects of floods is human settlements exposure due to their location in the floodplains (Photo 3).
