# THE INTENSIFICATION OF ANTHROPIC PRESSURE THROUGH THE EXPANSION OF THE CONSTRUCTED AREA IN THE SUBCARPATHIAN SECTOR OF THE PRAHOVA VALLEY/ROMANIA (1800-2008)

Florin VARTOLOMEI<sup>1</sup>, Iuliana ARMAȘ<sup>2</sup>

<sup>1</sup> *Spiru Haret University, Bucharest / Faculty of Geography and Tourism Geography, fvarolomei@yahoo.com*

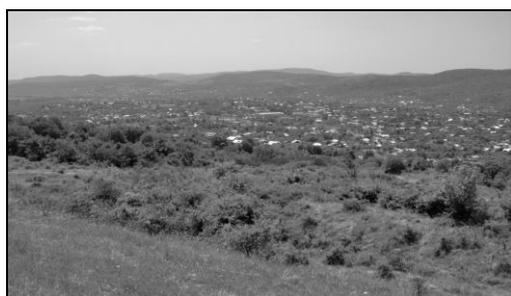
**Fig. 2 Left - Terrace plain of Lower Cornu seen from the Plaiu Cornului ridge; Right - General overview over Breaza settlement**

**Cornu** town had 4,475 inhabitants in 2002, from which 2,152 are males and 2,323 females and 1,659 buildings in total. In all this buildings, according to the census in 2002, there were 1,860 permanent residences (including 5 spaces used for trading purposes), which includes 5,876 rooms in total (Yearbook, 2003) (Fig. 2 - Left).

**Breaza** town had 18,199 inhabitants in 2002, from which 8,964 are males and 9,235 females. There were 6,078 buildings in total. In all these buildings, according to the census in 2002, there were 7,368 permanent residences (including 46 spaces used for trading purposes), which includes a total of 22,697 rooms (Yearbook, 2003) (Fig. 2 - Right).

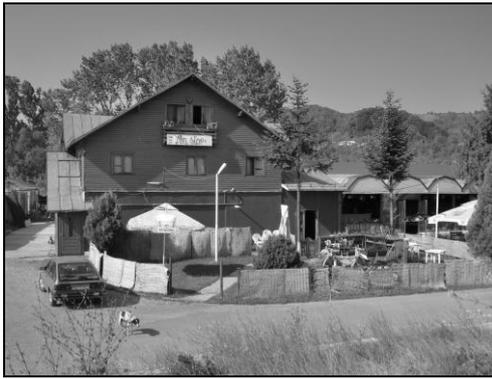
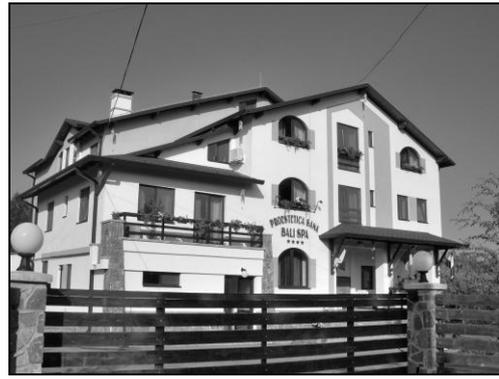
Fig. 3 New buildings in Cornu settlement

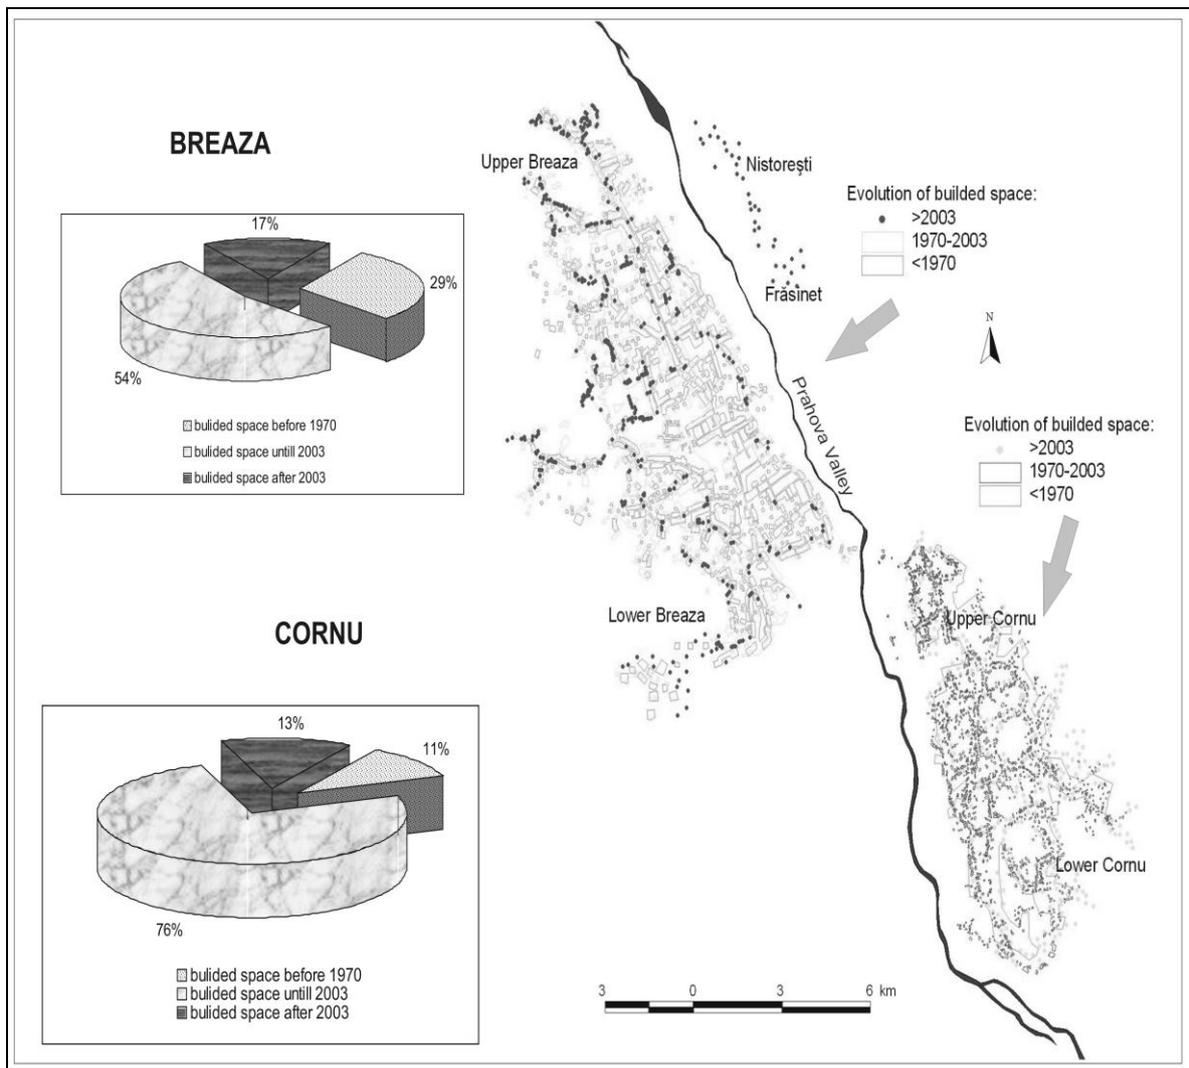
Fig. 4 Comparative situation between Breaza and Cornu

The new buildings are located especially in the hilly area of the city, with a higher density in Breaza de Jos and in the northern extremity. In this area the Breaza town has a diffuse structure regarding the distribution of the newly constructed buildings (Fig. 4). The streets are very irregular and have a pavement of concrete slabs placed transversally on the road axis, with a big influence on the drainage direction of the rain water and washed alluvia.

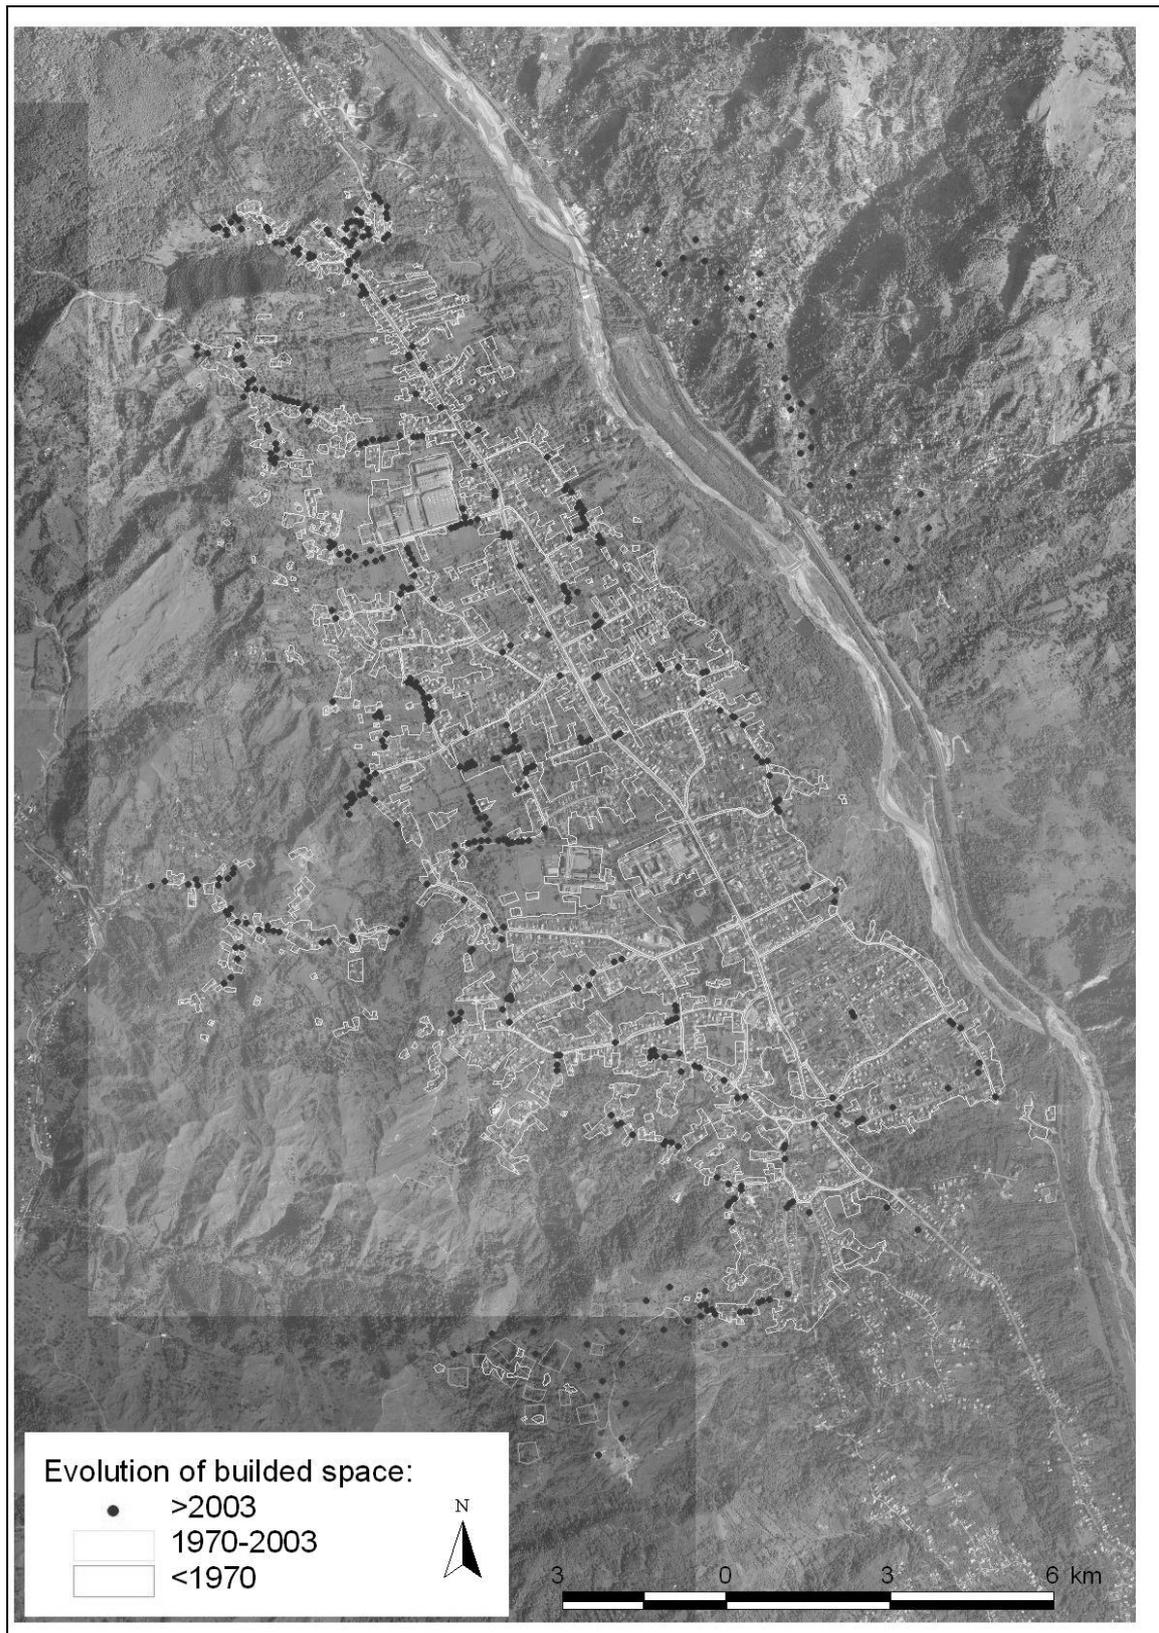
**Fig. 5** The evolution of the space built in BREAZA town (processed orthophotoplan image)

The representative streets mapped for this type of construction are Poenița Street, Putna Street, Coștila Street, Rășărit Street, Oituz Street, Sunătoarea Street, Tineretului Street (Fig. 5).

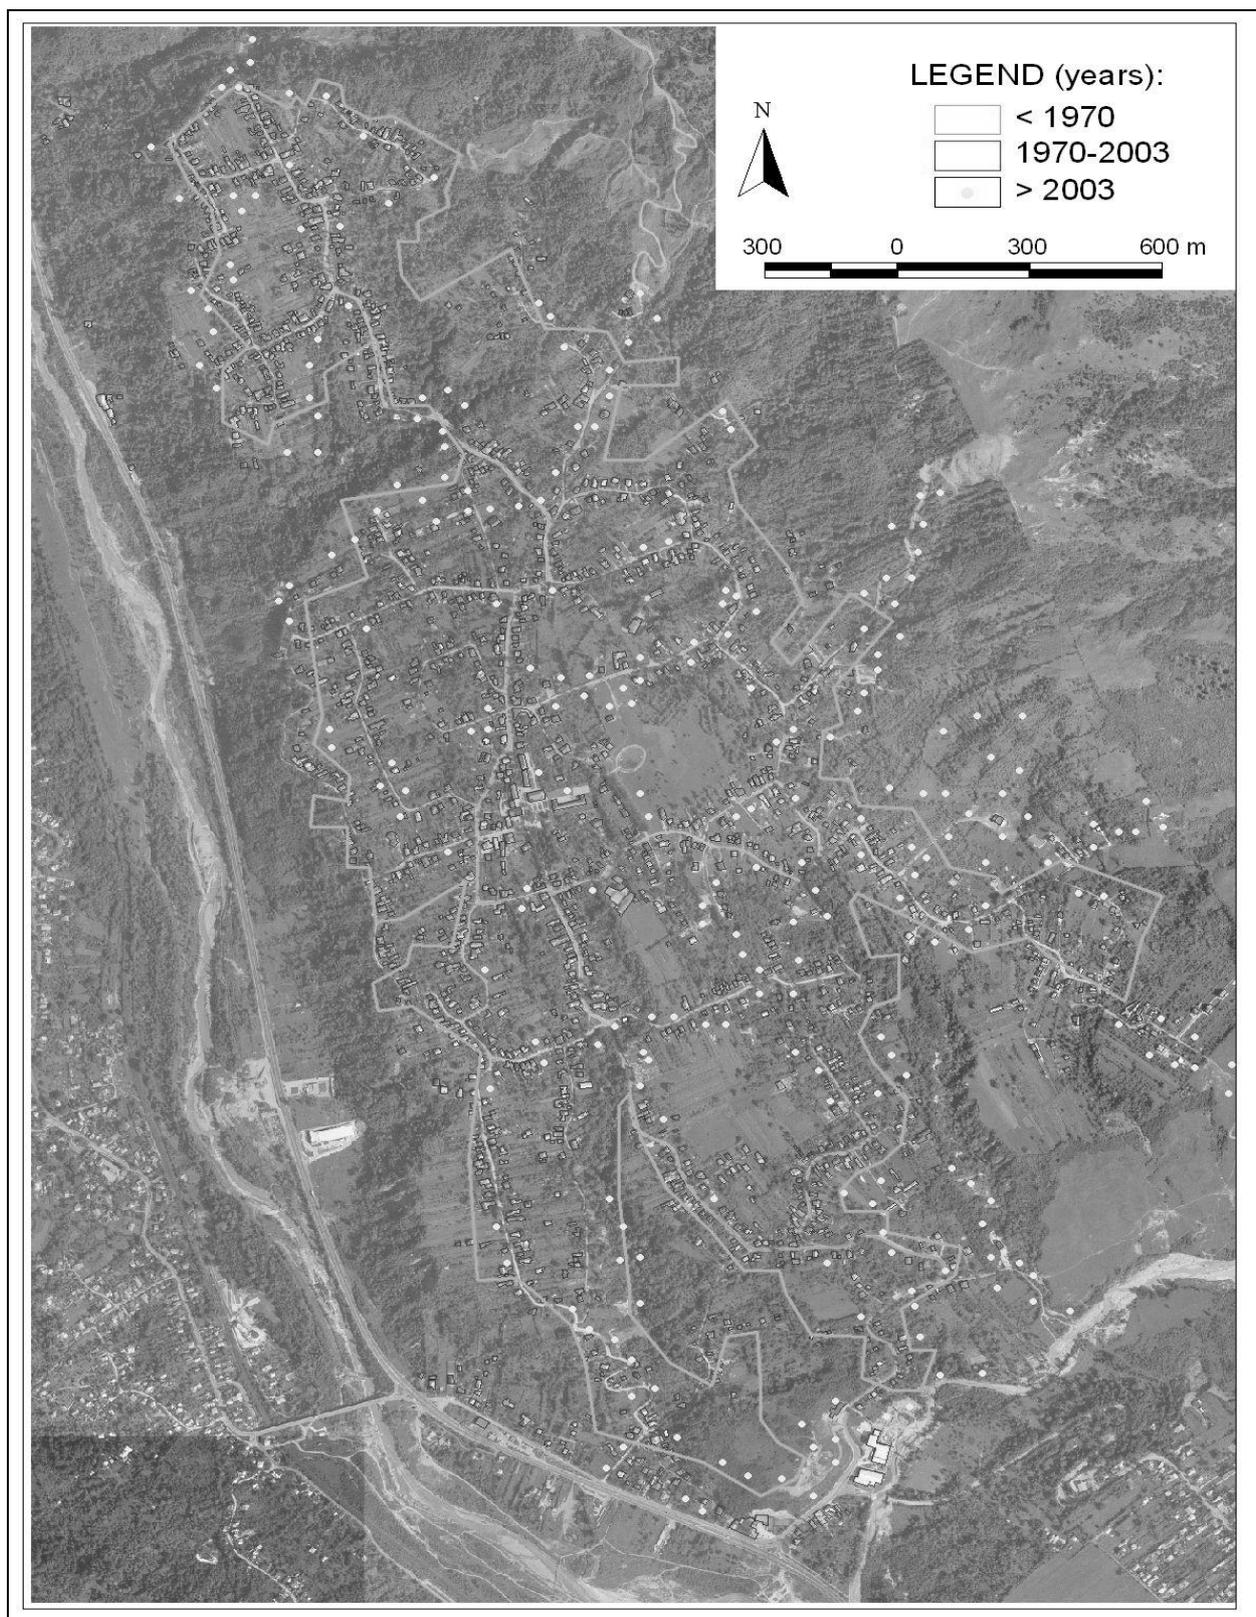
**Fig. 6** The evolution of the space built in CORNU settlement (processed orthophotoplan image)

The buildings from the 2<sup>nd</sup> and 3<sup>rd</sup> category are most common in the northern extremity of the town, on the terrace scarp (in this area the town has a linear structure) as most of the buildings in Cornu. The buildings, because the material they are made of have a high potential to trigger the phenomena with a geomorphologic risk, but their difficult location (difficult access, etc.) determine a small number of buildings of this type (Fig. 3). The representative streets mapped for this type of constructions are: Piatra Arsă Street, Sulfinelor Street, Dunărea Street, Colin Street, Rugului Street, Panslelor Street, Porumbari Street, Micșunele Street, Fagului Street, Cerbului Street (Fig. 6).

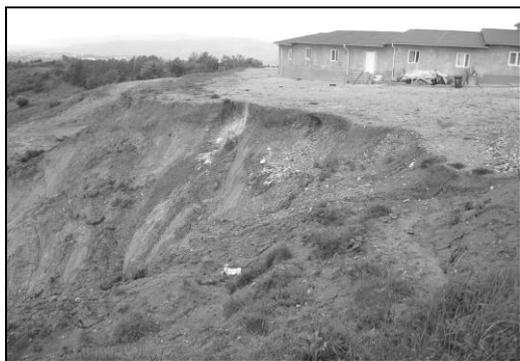
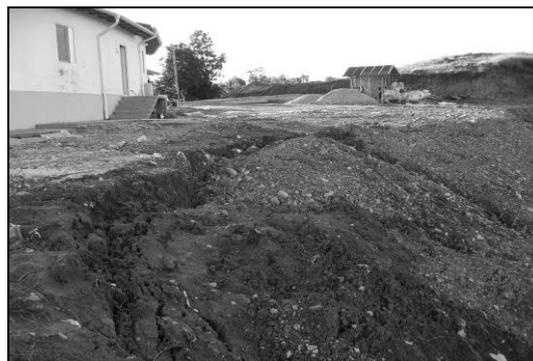
**Fig. 7 Recent landslides in Cornu settlement (stage in 2008 - left; stage in 2009 - right)**

For new constructions, the issue regarding the foundation was not properly approached, there had not been performed any studies regarding the loading of the slope with the respective constructions, with waste materials, as well as studies concerning the taking over and drainage of rain and sewerage waters (improper sewage networks, septic tank etc.). Constructing these buildings - located on the edge of the terrace and/or "cut" into the slope, as well as all trenches performed for foundations/ walls and underground laying of cables and pipes – represented the cause induced by the human action that favoured the landslides occurred in 1992, 1997 and those from the autumn of 2005 and the summer of 2008 in Cornu settlement (figure 7).
