Quality assessment indicators of surface waters and soils in the vicinity of the former sulfur mine in the Călimani Mountains

A native sulfur mineralization was quarried out intensively for a period of almost 30 years in Călimani Mountains, the Eastern Carpathians. The waste resulted from this exploitation activity was stored in four waste dumps, while the residues resulted from the processing were disposed in a settlement pond. Although mining operations closed in 1997, the remains of the former sulfur mining are listed among the major pollutants in Romania.

The present paper intends to present a preliminary analysis and the current state of the impact of pollution of the former mining exploitation on different environmental factors, by assessing some quality indicators of surface waters and soils. Water and soil samples from different areas situated in the proximity of the former mine were collected and analyzed, performing pH, conductometric, turbidity, chemical and microbiological determinations.

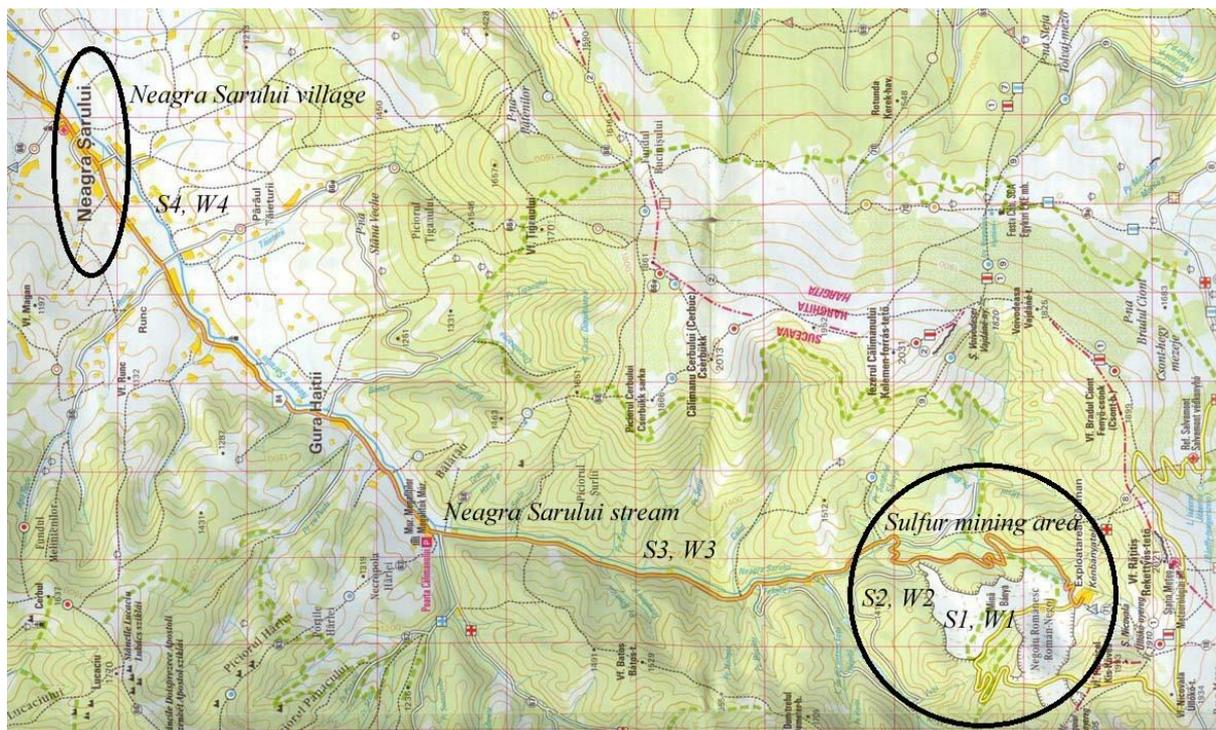
Fig. 1: Map of the former Călimani sulfur mining exploitation area and its vicinity

Solid soil samples (S1-S4) from the quarry, waste dumps and water samples (W1-W4) from the seasonal puddles developed onto the plateaus of the quarry, waste deposits and from Neagra Șarului stream were collected and analyzed. The samples were collected from representative areas, thus to cover a distance of about 5 km around the mining operation region. Samples were collected from the epicenter of the mining area (S1, W1), from the plateau of the Puturosu waste deposit (S2, W2), from the stream crossing the mining area (S3, W3) and from the stream at the entrance of Neagra Șarului village (S4, W4) (Fig. 1). All the samples were collected from the designated areas in June 2013.

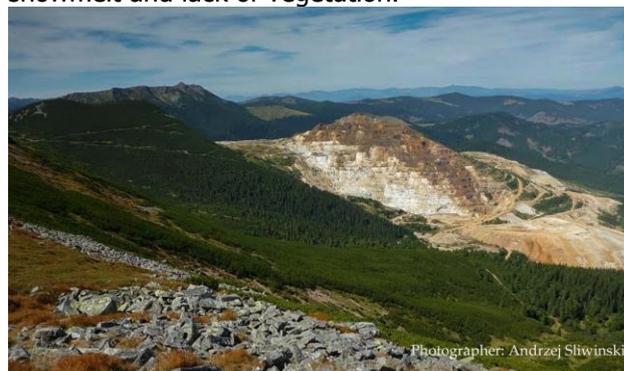
An area covering more than two kilometers all around the former quarry operation is affected by the presence of sulfur. We could notice the lack of vegetation and the heavy sulfur smell the air. The water samples collected from the puddles developed onto the plateaus of the quarry and waste deposits were murky, yellowish and had a characteristic sulfur smell.

There were also noticed crashes and shifts of boulders and rocks on the bare slopes. The shaped

forms of terraces testify for the influence of rainwater flows. The structure of altered, permeable and destabilized rocks caused the formation of drainage ditches. The frequency of landslides is high due to the existence of potential conditions: unstable and permeable rocks, steep slopes, destabilized material entrained by water rainfall or snowmelt and lack of vegetation.

Fig. 2: Image of the former mining exploitation from Călimani

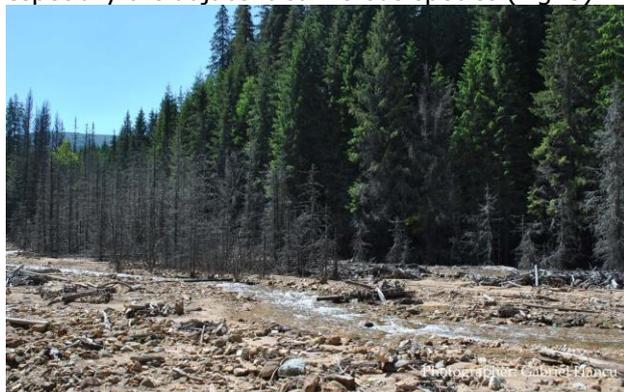
After analyzing the results, we can state that the water and the soil samples collected near the mining area have a very acid pH, incompatible with the aquatic life. We also observed that, following the seasonal water level rise, the sensitive vegetation at the bank of the stream was heavily affected, especially the adjacent coniferous species (Fig. 3).

Fig. 3: Effects of water acid pH from Neagra Șarului stream on the vegetation surrounding the mining area

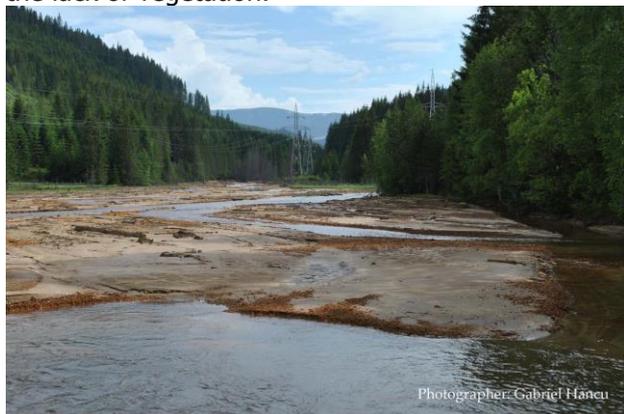
It is also worth mentioning and very alarming that in an inhabited village like Neagra Șarului, the pH of the water crossing the settlement is around 4.00. At the entrance of Neagra Șarului village, deposits of sediments from the mining area can be observed, due to the development of a natural dam (Fig. 4). Soil samples collected from the mining area had also disturbing acid pH values, which explains the lack of vegetation.

Fig. 4: Deposit of sediments near Neagra Șarului village

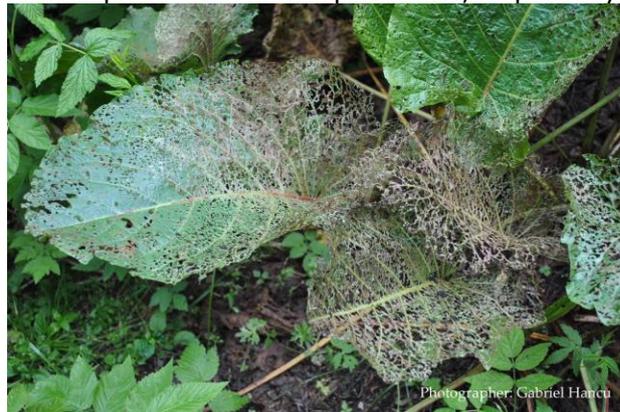
We also discovered signs of potential acid rains, as acid rains attack plants, first of all their leaves (by blocking the respiratory system and disrupting the processes of photosynthesis), but also the roots of trees (by neutralizing soil nutrients). The high concentrations of sulfur dioxide can cause acute injury to leaves as foliar necrosis, even after a relatively short exposure time (Fig. 5). The sulfur is discharged into the air as sulfur dioxide and sulfur trioxide; and these in combination with rainwater form sulphurous acid and sulphuric acid, respectively.

Fig. 5: Effects of acid rains over the leaf lamina

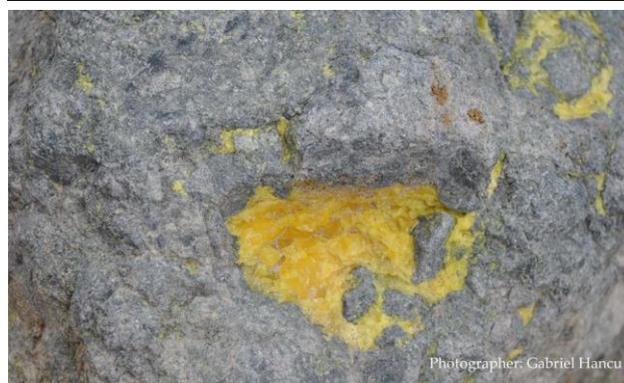
Numerous sulfur deposits were found on the rocks near different water flows and especially in the ford of Neagra Şarului stream (Fig. 6).

Fig. 6: Sulfur deposit on the rocks of the Neagra Şarului stream ford
