The Assessment of Artificial Water Surfaces Regeneration in Satchinez Swamps Protected Area by Using Remote Sensing and In-situ Data

Marcel TÖRÖK - OANCE^{1,*}, Rodica TÖRÖK - OANCE²

Abstract

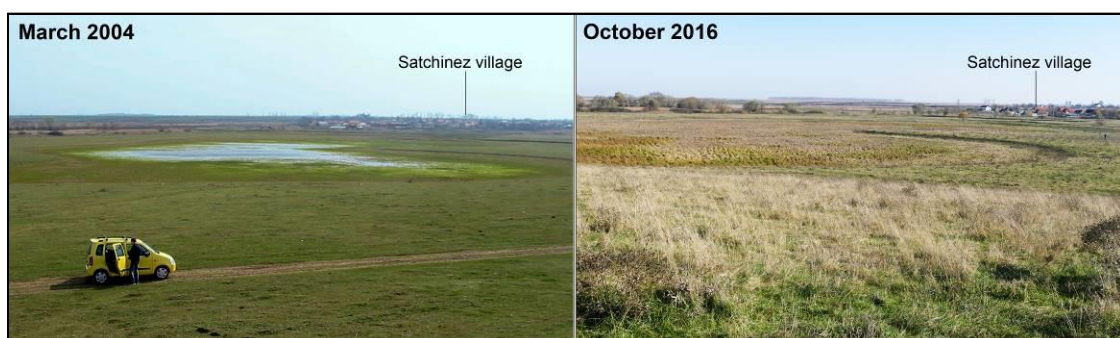
Fig. 7: Balta Mare during the rainy season (March 2004) and the dry season (October 2016). The reed expansion in the central part of the lake basin is obvious in the picture from 2016

On all mapping and orthographic materials under analysis, Balta Mare is clearly outlined, having almost the same size and shape, both before and after the draining works. This is due to the existence of a depressionary landform, highly visible in the land surface, approx. 1.5 m deep in the west, at the base of the slight slope of Iarcu Mic hill. In this area, Balta Mare is clearly outlined from the hill slope by a steep slope sector. In our opinion, the lake basin of Balta Mare is created by suffosion and compaction of loess-like deposits forming the geological sub-layer of the study area. Such loess sinkholes were already noticed in this area (Morariu, 1946). The lake basin was also shaped by river erosion, due to its location in the former watercourse of Sicsău river (according to the 1963 orthophoto) and also by its relatively regular, meandered shape. The existence of this negative, concave landform explains why, in spite of the efforts made for draining the area, Balta Mare could never be transformed into a pasture, and retained its character of wetland meadow and, for several month per year, temporary pond (Fig. 7).

MNDWI was used to detect the presence of water in Balta Mare. During all the rainiest months (May or June Landsat scenes), one can observe the presence of water in Balta Mare area demonstrated by slightly positive values of MNDWI. No significant differences are observed after 2005. The MNDWI values extracted from all August and September Landsat scenes are negative, which demonstrates the lack of water. The situation is also similar after the construction of the water supply canal for Balta Mare. This clearly shows that the restoration works of the area did not lead to the recovery of Balta Mare. Despite the construction of the water supply canal, it dries up during dry months. The comparative analysis between T1 and T2 shows a slight decrease in MNDWI values, which can be explained by the advancement of reed (Fig. 7).

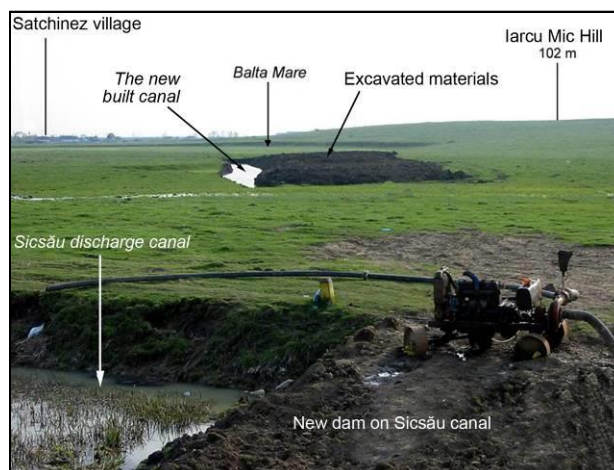
Fig. 8: The hydrotechnical works and construction of the water delivery canal in 12th April 2005

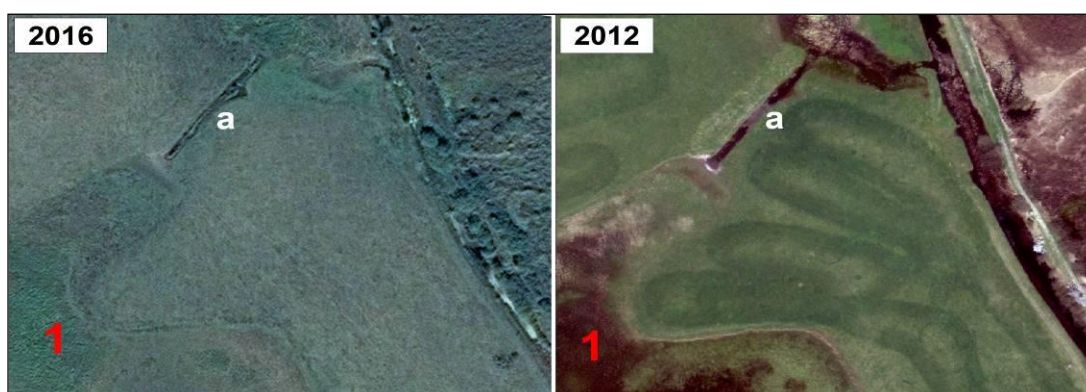
Fig. 10: Advanced clogging stage of the water supply canal (a) in 2016 (source Google Earth) compared with 2012 color orthophoto. 1, Balta Mare

demonstrates its temporary character, despite the restoration works. It can also be noticed the advanced clogging stage of the water supply canal in 2016 (Fig. 10), a fact which we also noticed on site (Fig. 11).

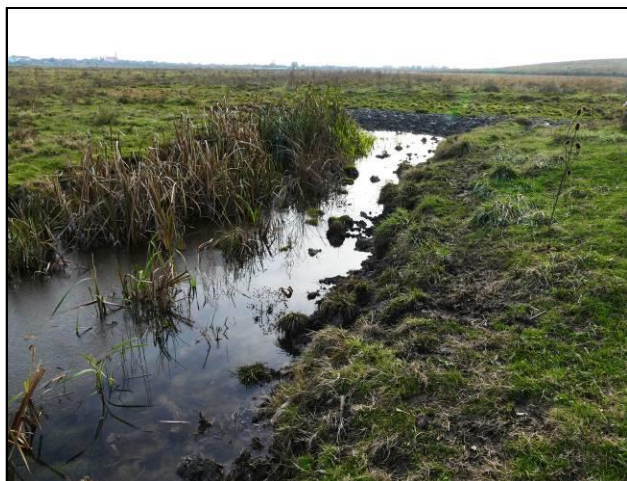
Fig. 11: Advanced clogging of the water supply canal built in 2005. The banks are eroded or covered with reed (October 2016)

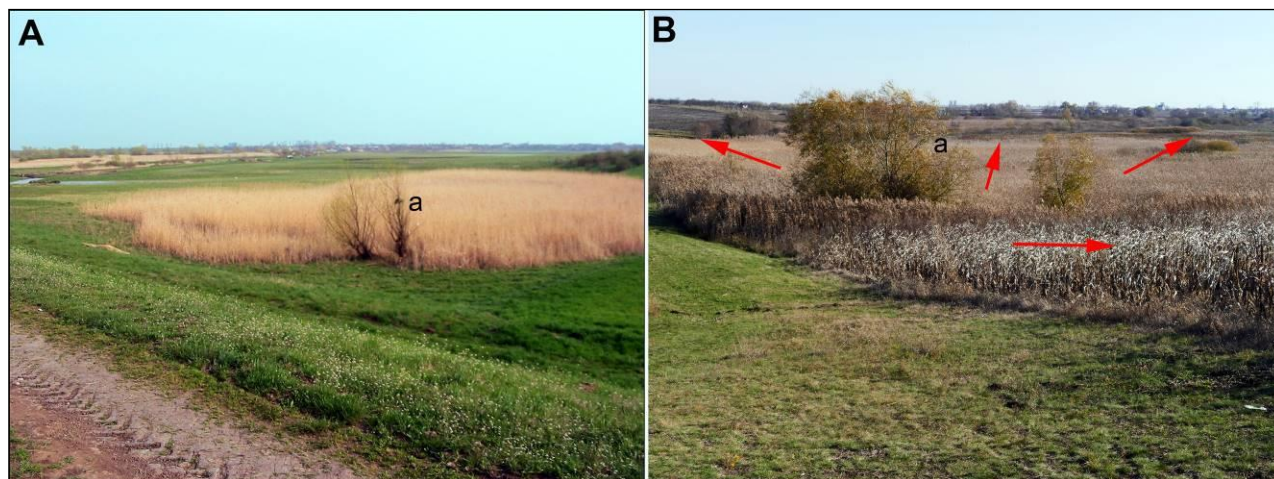
Fig. 13: Reed occurrence in 2004 (A) and in 2016 (B) at the relict watercourse of Sicsău stream south of Stachinez reservoir. The red arrows show the reed expansion directions. a, tree as a reference point
