The changing river course and its impact on riverine society: A case study on the Padma River, Murshidabad District, West Bengal (India)

Dr. Sanatan GHOSH^{1*}

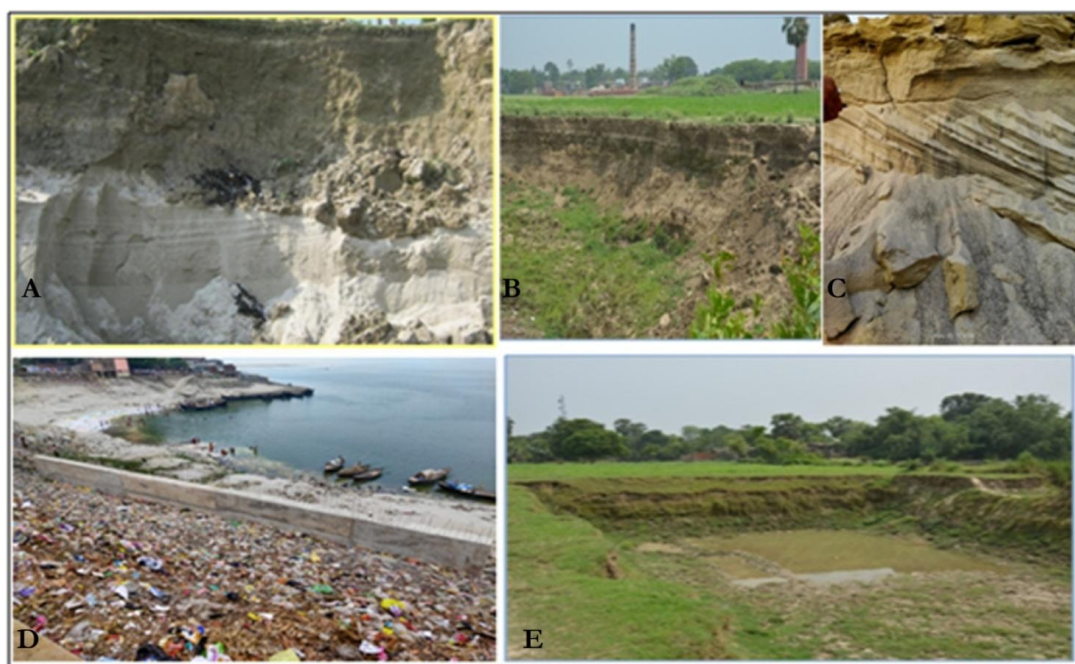
Figure 7: Trigger factors of lateral erosion - A. Unconsolidated Sand at bottom and thin silt clay soil at top at Maya, Lalgola; B. Human interference (Brick field) along the river bank at Maya; C. River bank characteristics near Dhulian; D. Construction of Bank Protection Wall at Dhulian; E. Illegal digging along the river bank at Maya

ii. Stratigraphy of a bank composed of micaceous unconsolidated sand at bottom and thin silt clay at top causes severe bank erosion (Figure 7).

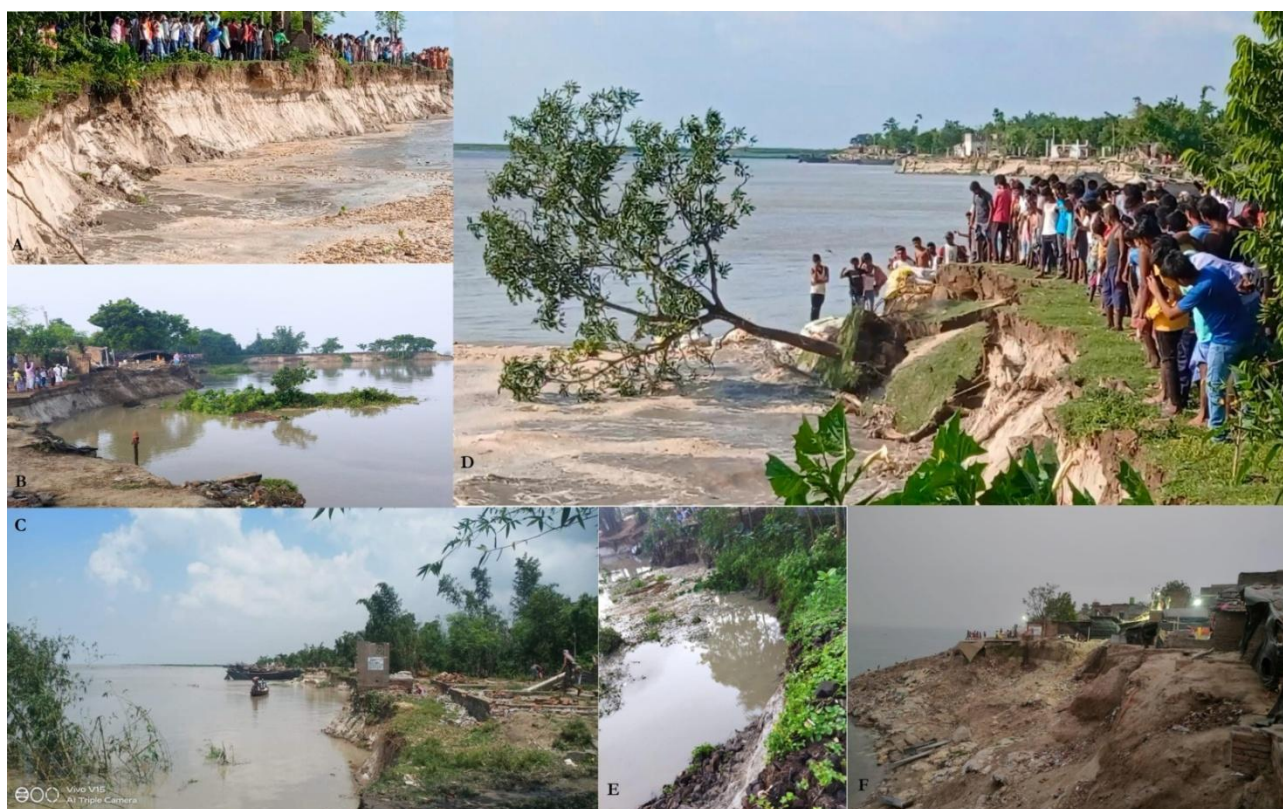
Figure 12: Present status of the Padma River bank erosion – A. Recent River Bank Erosion Ground truth evidence at Farakka; B, D & E. Recent River Bank Erosion Ground truth evidence at Dhulian (During Bank Erosion); C. Recent River Bank Erosion Ground truth evidence at Maya (Lalgola); F. Recent River Bank Erosion Ground truth evidence at Dhulian Municipality ward no 17

iv. According to the study, 22% of the study area's residents are at risk for river bank erosion since they reside close to the bank line (Figure 12).
