Former gas stations in Timișoara area – Inventory and analysis of recognised environmental conditions

Raluca VĂDUVA^{1,*}, Mircea VOICULESCU¹

¹ Department of Geography, Faculty of Chemistry, Biology, Geography, West University of Timișoara, Romania

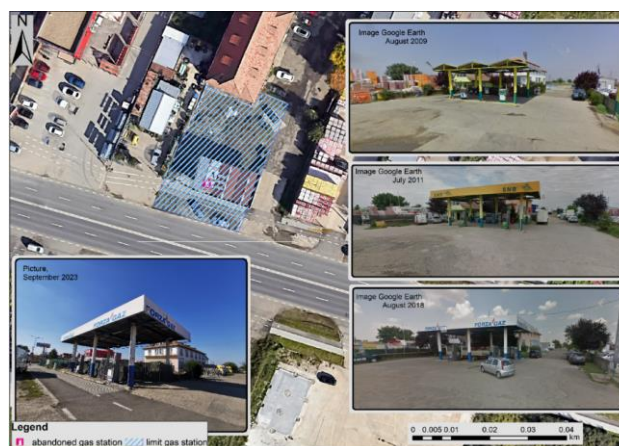
Figure 2: Former gas station, Calea Buziașului

The former gas station is located in the urban area of Timișoara, on Calea Buziașului, covering an approximate area of 800 square meters (Fig. 2). According to the Timișoara Urban Planning General Plan (PUG), the site falls within a mixed-use zone, combining residential and service-related functions. The neighbouring land use is diverse, including construction material depots, specialised installation companies, transportation firms, auto parts stores, and auto service centres. Additionally, there are some greenfield areas nearby.

No evidence of underground tank removal was found. However, upon comparing on-site images (Fig. 3 c) with Google Maps images (Fig. 2 and Fig. 3 d), it can be inferred that the tanks were most likely removed. Traces of construction materials were also identified, likely resulting from the demolition of buildings on the site.

The analysed site presents the following Recognised Environmental Conditions (RECs): there is a potential risk of accidental fuel leaks, various waste, or used oil from equipment or vehicles on the site, as well as from handling other hazardous substances or waste on the premises. A detailed soil investigation could confirm or refute the presence of hydrocarbons.

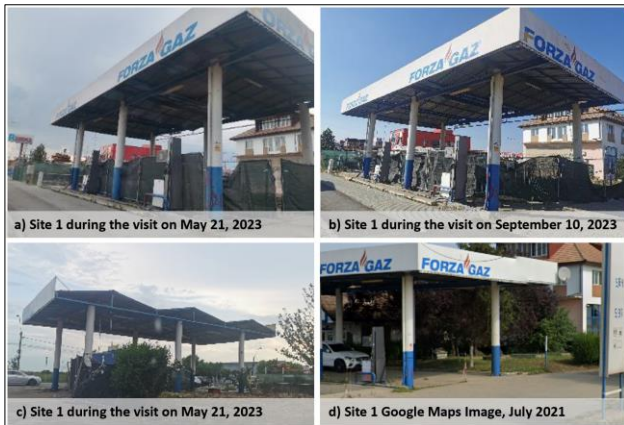
Figure 3: Site 1 during field visits and on Google Maps

No environmental permits have been identified for this site in the public documents on the Environmental Protection Agency (APM) website. The historical information regarding this location consists of Google Maps images dating back to August 2009, which revealed three different fuel providers. The site inspection involved physical observations of the location on May 21, 2023, and September 10, 2023, during field visits (Fig. 3. a, b). Access to the subject property was not directly restricted, however, the site was fenced to prevent unauthorised entry. The fuel distribution pumps were still present at the site during the visit.

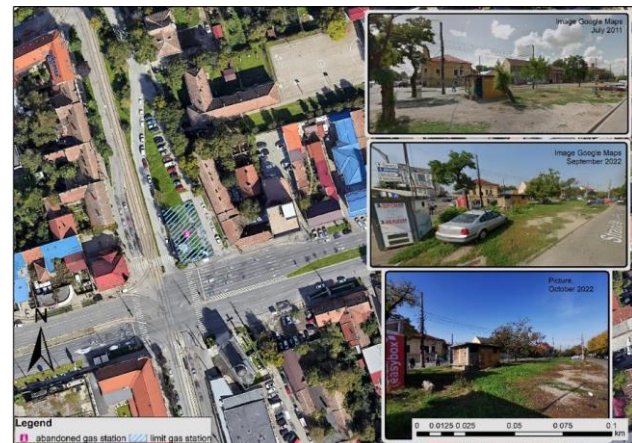
Figure 4: Abandoned gas station, Badea Cârțan Square

This site is situated in the urban area of Timișoara, at the intersection of Simion Bărnuțiu and Mihail Kogălniceanu streets, near Badea Cârțan Square (Fig. 4), covering an approximate area of 500 square meters. According to the old Timișoara Urban Planning General Plan (PUG), the site was categorised as a green space, while the new PUG designates it as a street area. The surrounding area has diverse land uses, including small commercial spaces of various types, such as pharmacies, medical offices, a church, an agro-food market, residential buildings etc. During field visits, the site was found to be a former gas station. Most of the facilities on the premises have been removed. The gas station was operational before 1989 and closed after 1990. Based on publicly available information, it was difficult to determine the exact construction and operational dates of the gas station or the closure date.

The site is unfenced, and people have created pathways through this site or parked their vehicles in the absence of designated parking areas (Fig. 4). Regarding the subject property, there are Recognised Environmental Conditions (RECs) including the theoretical potential risk of accidental fuel leaks, various waste, or used oil from equipment or vehicles on the site, as well as from handling other hazardous substances or waste on the premises. A detailed soil investigation would be necessary to confirm or refute the presence of hydrocarbons in the soil.

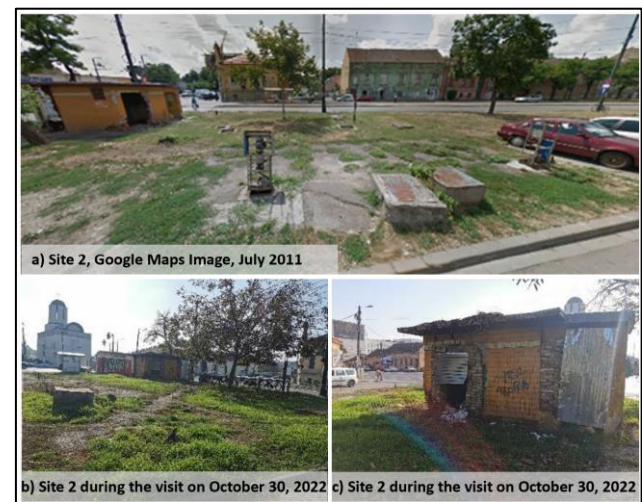
Figure 5: Site 2 during field visits and on Google Maps

No environmental permits have been found for this former gas station in the public documents on the APM website. Historical information about this location includes Google Maps images dating back to July 2011 (Fig. 5 a). Even back then, the space looked abandoned, with evidence of fuel pumps and underground tanks (manhole or manway covers). A site reconnaissance involving physical observations was conducted on October 30, 2022 (Fig. 5 b, c). At the time of the field visit, there were no restrictive conditions related to site access.

The site shows evidence of prior asphalt paving, which has deteriorated over time and is now covered by vegetation or gravel (Fig. 5 a). Additionally, the ruins of the gas station building were identified, which facilitate illegal waste deposition (Fig. 5 c). Evidence of the existence of

underground tanks on the site was also found (manhole or manway covers - Fig. 5 b).

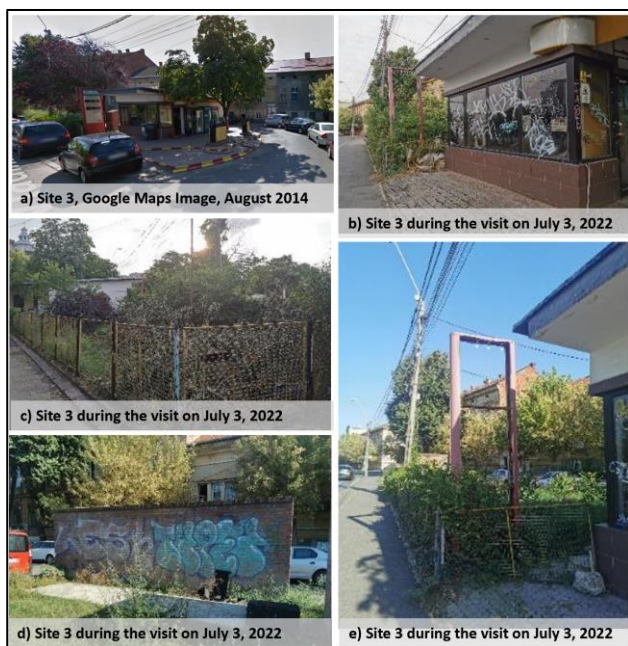
Figure 7: Site 3 during field visits and on Google Maps

There are no environmental permits for this location in the public documents from the APM website. The only historical information that could be accessed about this site is from Google Maps images dating back to July 2011, which indicate that the space appeared abandoned, with evidence of fuel pumps and covered underground tanks.

Physical observations of the site were conducted on 03.07.2022 and 10.09.2023 (Fig. 7 b-e). During the field visits, there were no restrictions on accessing the site. It

was observed that the two pumps had been removed (Fig. 7 e). The gas station building was well-preserved, but it had been abandoned and attracted street artists who left graffiti-type signatures (Fig. 7 b, d). Evidence of underground reservoirs (manhole or manway covers) was found on the site (Fig. 7 d). The site is well-fenced off, limiting public access (Fig. 7 c).

Regarding the subject property, there are several RECs to highlight. Firstly, there is a theoretical potential risk of accidental fuel leaks, along with the possibility of various waste or used oil from equipment or vehicles on the site. Additionally, hazardous substances or waste might be handled on the premises. A comprehensive soil investigation could confirm or disprove the presence of hydrocarbons.

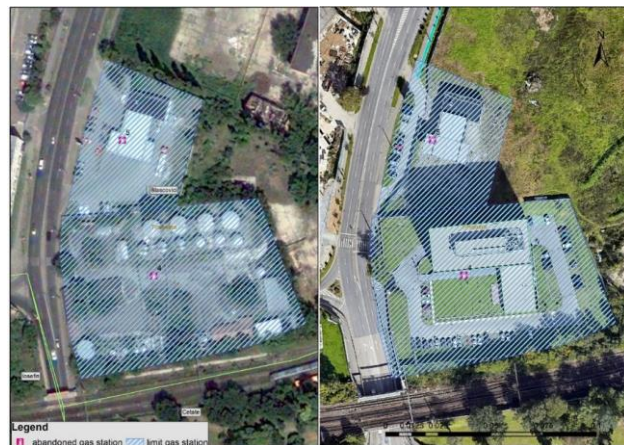
Figure 8: Abandoned gas stations, Calea Circumvalațiunii

The two sites are situated within the urban area of Timișoara, on Calea Circumvalațiunii (Fig. 8), with an approximate area of 6500 square meters and 3000 square meters, respectively. According to the Timișoara General Urban Plan (PUG), the subject properties are located in an area designated for redevelopment of industrial sites, allowing mixed functions: residential, services, and commercial use. The surrounding land use includes service areas (i.e., offices), residential buildings and commercial spaces. Furthermore, former industrial sites that have been restructured and are mostly cleared can be found. The Caransebeș-Timișoara-Arad railway line and its associated buffer zone are situated along the southern part of site #4.

Regarding these two sites, the following RECs can be highlighted: a theoretical, potential risk of accidental fuel leaks, various waste, or used oil from equipment or vehicles on both sites or from handling other hazardous substances or waste on the site. Also, a detailed soil investigation could confirm or refute the presence of hydrocarbons.

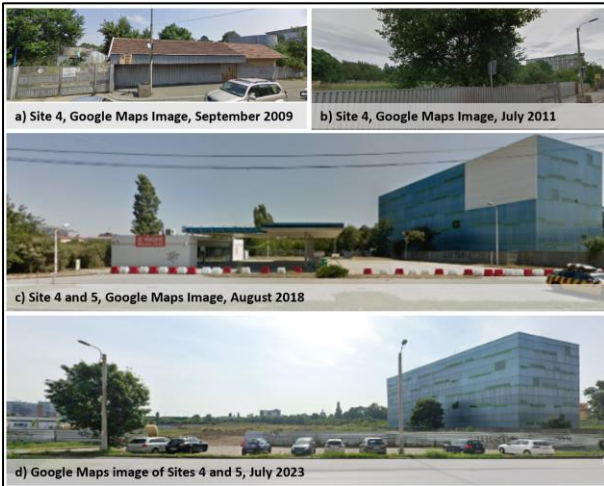
Figure 9: Site 4 and 5 on Google Maps

No environmental permits have been identified for the two locations in the public documents on the APM website. Historical information regarding these sites consists of Google Maps images dating back to August/September 2009 (Fig. 9 a, Fig. 10 a). It can be observed that both locations were in use in 2009, but by 2011, Site 4 was already decommissioned (Fig. 9 b).

that closure occurred after that date. An image from August 2018 (Fig. 9 c) confirms that the location was abandoned and put up for sale.

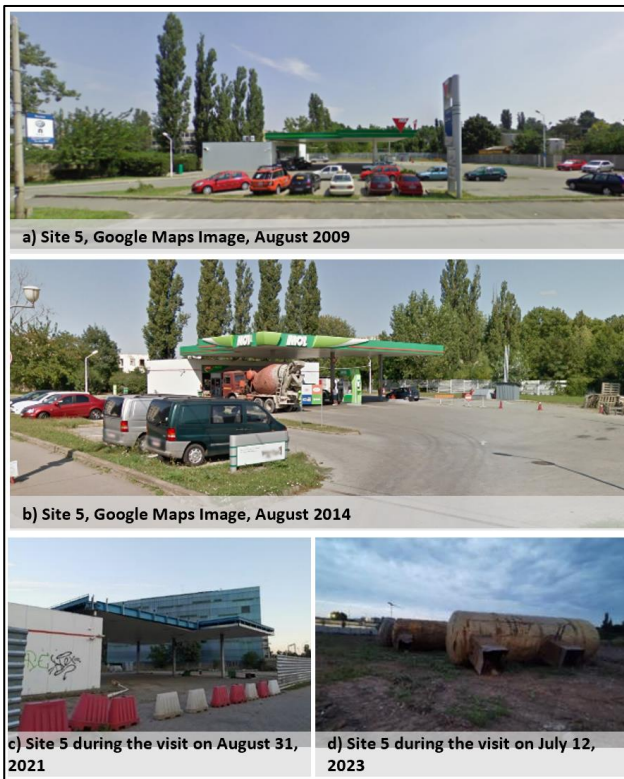
Figure 10: Site 5 during the site visits and on Google Maps

During the site visits, it was found that the former deposit and station for gaseous fuel #4 had been replaced by the Incubox building (Fig. 10 c), which now serves as a business incubator. Site #5 was occupied by a former gas station, which most of the installations were removed from (Fig. 10 c, d). Unfortunately, the exact construction date, or dates when the gas station was built or became operational, could not be determined, nor was there information on its closure date. However, according to the

Based on Google Maps images, the gas station (site #5) was still operational in August 2014 (Fig. 10 b), indicating

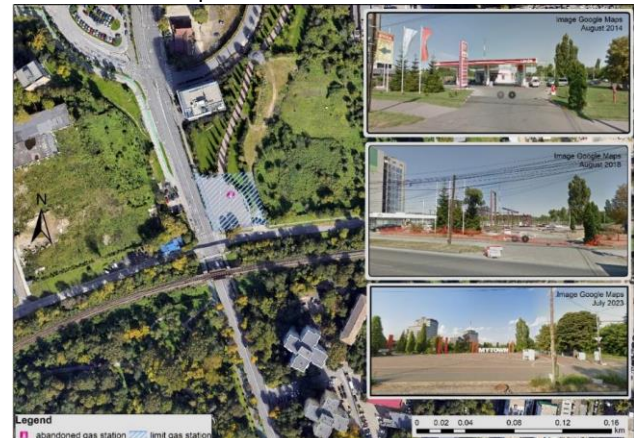
Figure 11: Former gas station, Calea Aradului

The site is situated within the urban area of Timișoara, on Calea Aradului, in the vicinity of Iulius Town recreational space, covering an area of approximately 2400 square meters (Fig. 11). According to the Timișoara Urban General Plan (PUG), the site is located in a functional service area. The neighbouring land use is mixed, including green spaces, office areas, a railway, and a residential complex built on a former industrial site.

During the field visits, the site had been either paved over or turned into green space as part of a real estate development project (Fig. 12). No evidence of any gas station was identified on this site. Based on available information, neither the construction or commissioning dates of the gas station nor the date of its closure could be identified. However, in August 2018, the site was mostly demolished (Fig. 11). Public documents on the APM website do not indicate any environmental permits for this site. Historical information about this location consists of Google Maps images dating back to August 2014, when the gas station was still operating (Fig. 11).

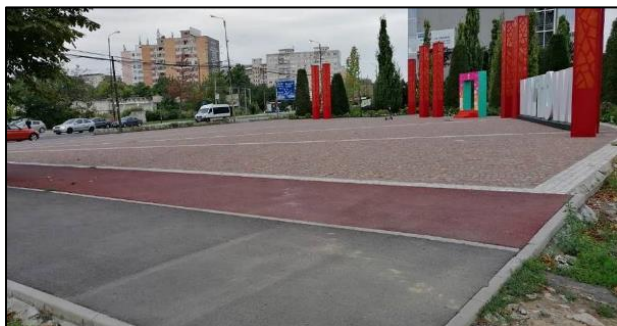
Figure 12: Site 6 during the visit in August 2021

Physical observations of the location were conducted in August 2021, with no restrictions regarding access to the property during the field visit. The site does not show any evidence of a gas station being present. The following Recognised Environmental Conditions RECs are noteworthy for this site: there is no visible evidence of a risk related to accidental fuel or used oil leaks. However, a detailed soil investigation could confirm or refute the presence of hydrocarbons resulting from the operation or removal of the gas station.
